MARITIME HERITAGE MINNESOTA

Ann Merriman
Christopher Olson

Aitkin Wrecks Project 2015 Report

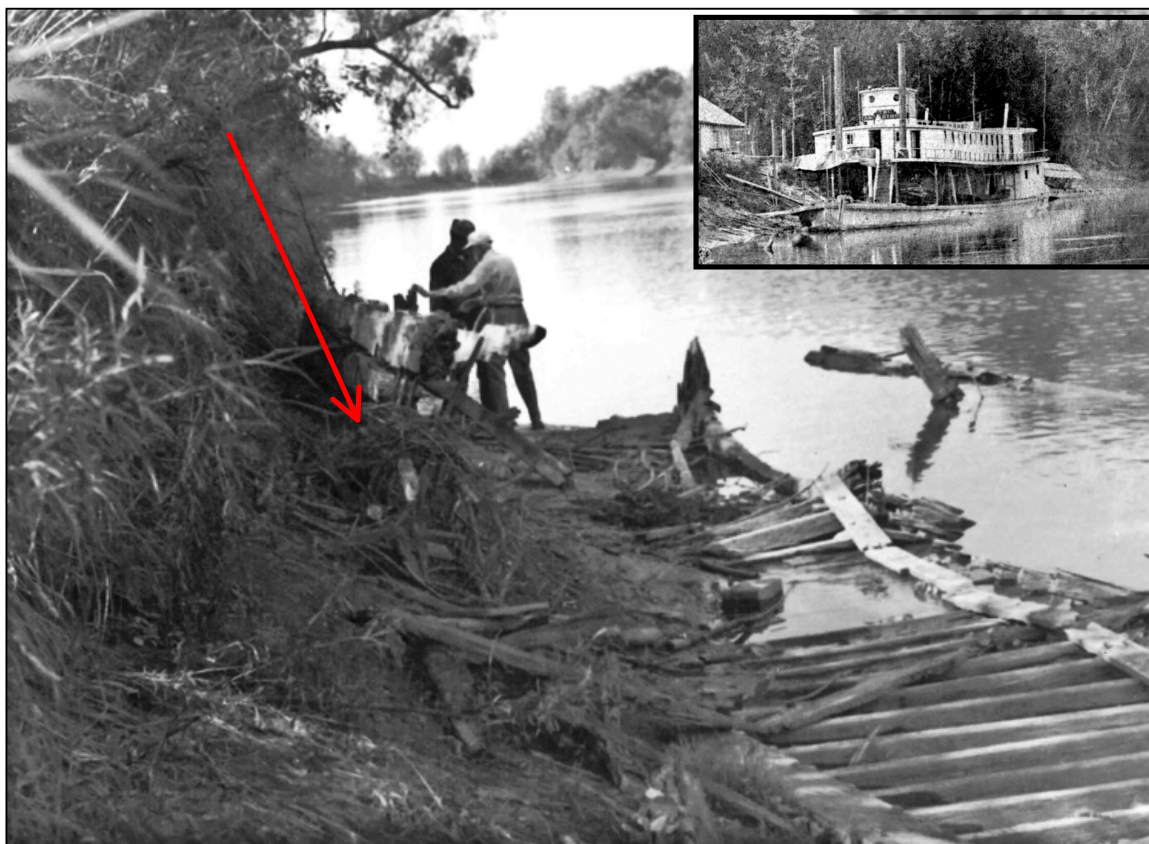
In 1967, *Andy Gibson's* starboard cylinder timber existed and was *in situ*. The location of Trench 5 is indicted by the red arrow (Aitkin Historical Society). Inset: *Andy Gibson* (Itasca Historical Society).

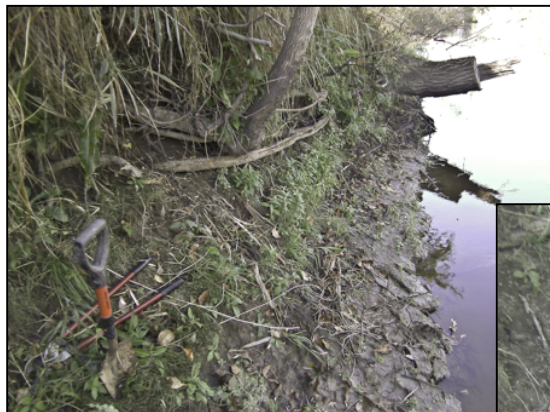
Left: The riverbank prior to opening Trench 5 and expanding Trench 1. The large cut tree stump hanging over the water is the remains of a tree that fell onto the wreck in 2013. See MHM's *Andy Gibson Wreck (21-AK-109) Fallen Tree Mitigation Report*, 2013, for details.

Right: Trench 5.

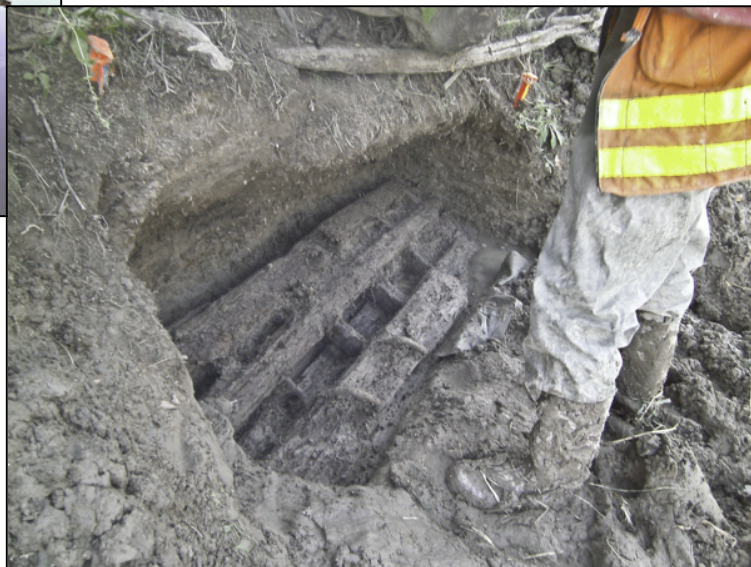
Left: The northern part of Trench 1. MHM opened up and expanded Trench 1 that was first opened in 2010. Note the green sandbags that filled the test trench near the wreck. MHM placed the sandbags in the trench prior backfilling.

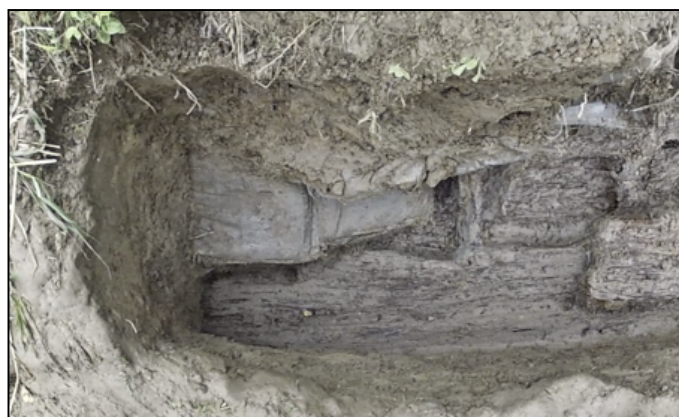
Below: Trench 1 on the left and Trench 5 on the right. The timber with the iron rods bent over it is the bottom portion of the starboard cylinder timber.

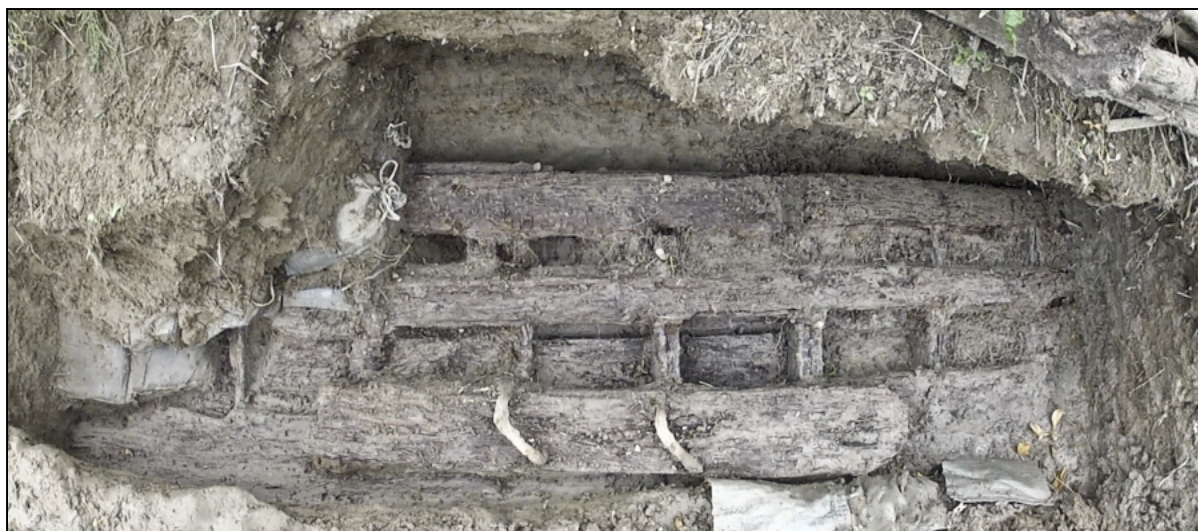
Trenches 5 (to the left) and 1 (on the right), delineated by the vertical lines outside the trenches. This plan also incorporates the south part of Trench 1 that was documented in 2010 and not uncovered in 2015. The river channel would be to the top of the image.

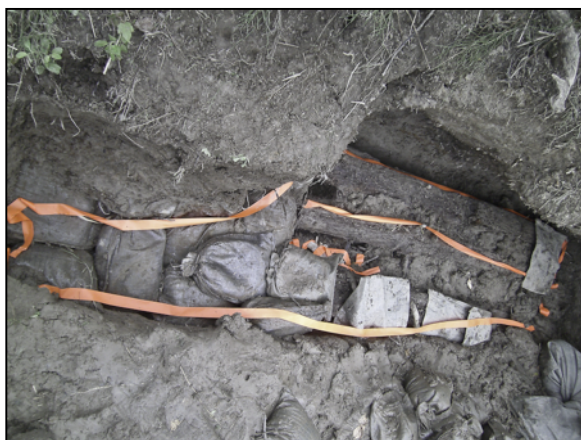
MHM placed orange tape around all wreck components before backfilling Trenches 1 and 5 in order to indicate that the area has been disturbed and to warn future researchers where the wreck lies. MHM also placed filled and empty sand bags onto certain wreck attributes for their protection.

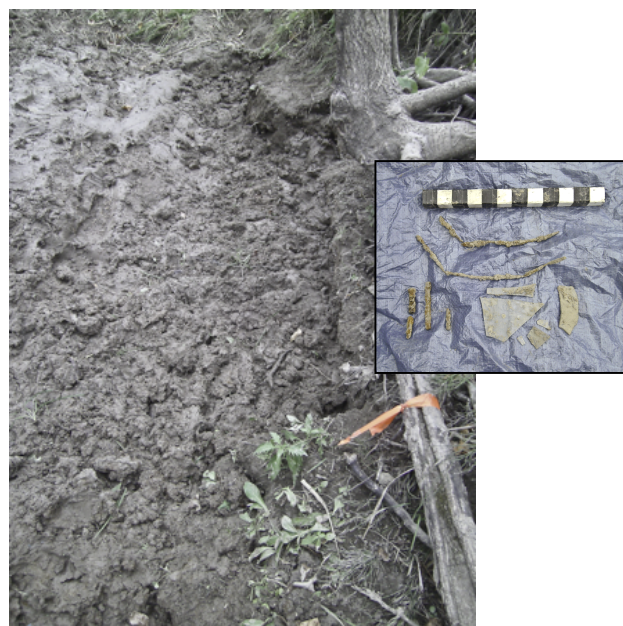
Trenches 1 and 5 backfilled. Inset: Left: MHM encountered artifacts in the matrix above the *Andy Gibson* in Trench 5. Nails, wire, and glass. The artifacts were wrapped in orange tape and placed back into the trench before backfilling.

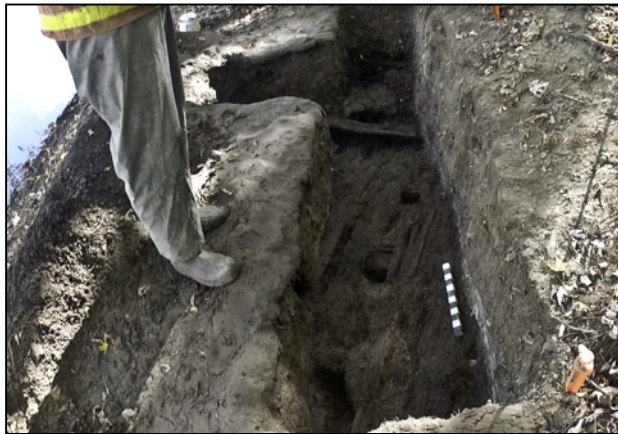
Trenches 4 and 5. Trench 4 is the long section that extends beyond the end of the wreck. Trench 5 is the small trench extending to the east toward the river channel.

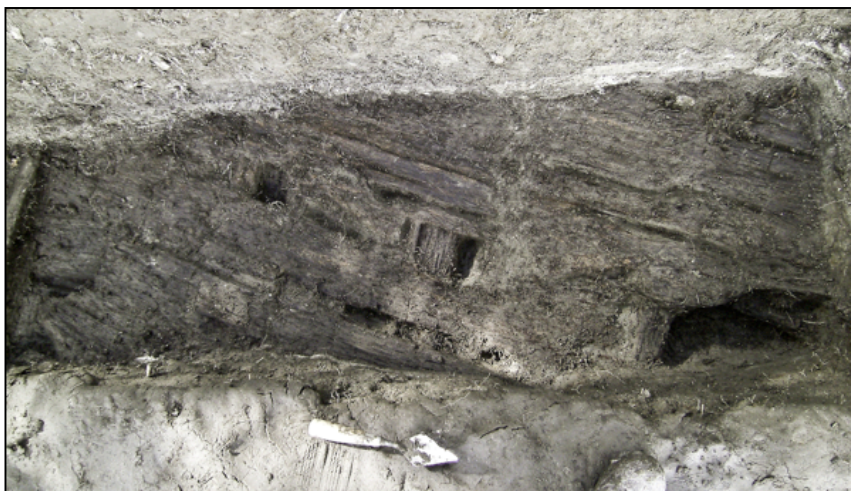
Trench 4 with its southern edge not included. Note the hole in the ceiling planking on the right side of the photograph where the outer hull has deteriorated.

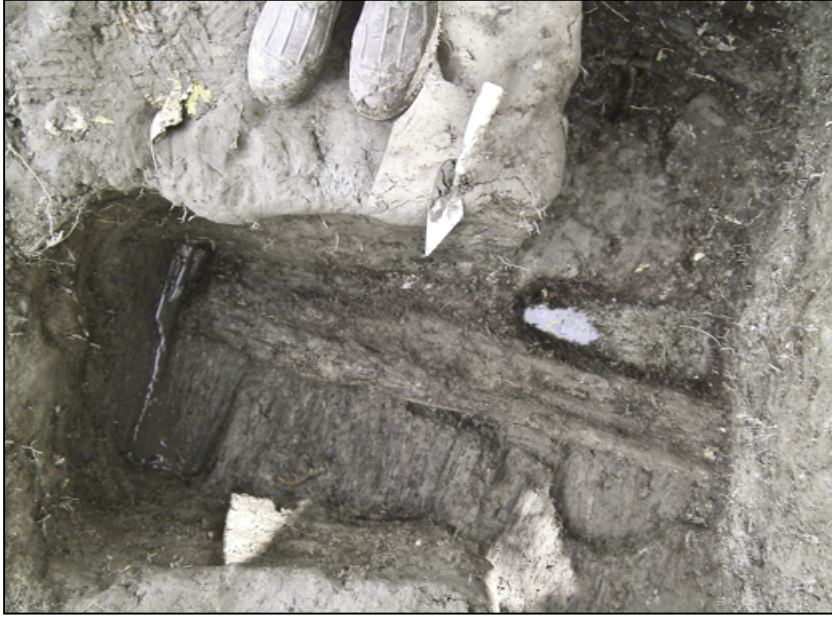
Trench 5 and the southern portion of Trench 4. The large beam that runs through Trench 4 into Trench 5 is the scow end of the Red Mill Wreck.

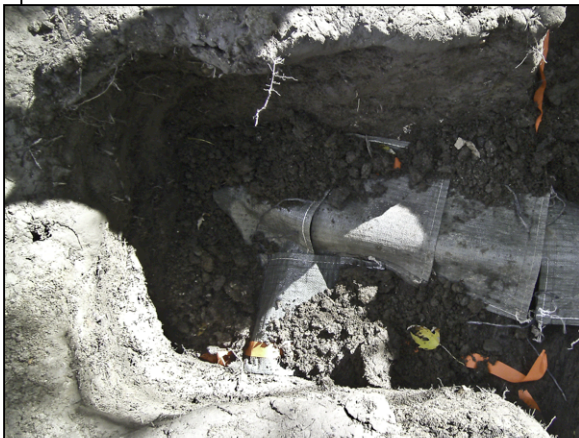
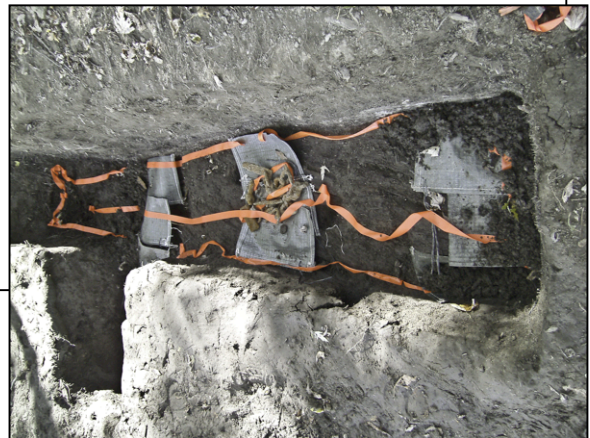
A drawing of Trenches 4 and 5 as it appears on the 2015 Red Mill Wreck Site plan. Orange warning tape and empty sandbags were placed in Trenches 4 (left) and 5 (above) prior to backfilling.

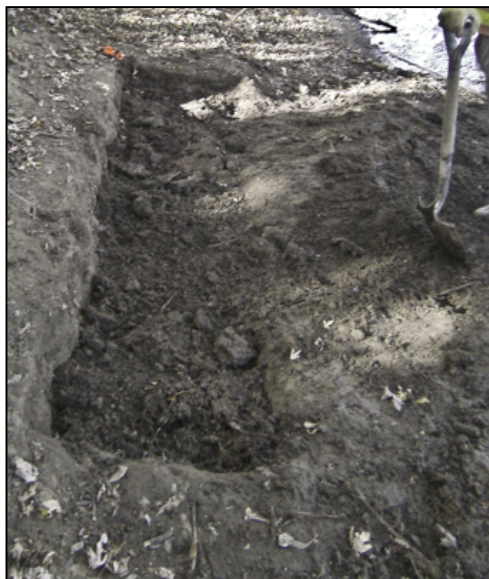
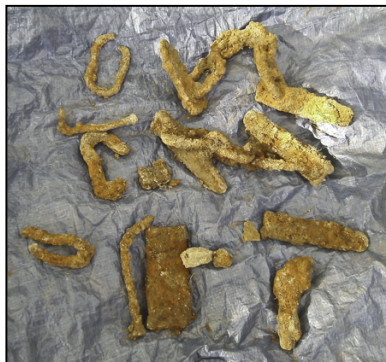
Backfilled Trenches 4 and 5, and the metal and coal artifacts located in the matrix above the wreck. Note the two complete logging spikes and the incomplete one comprised of one spike and broken chain links.

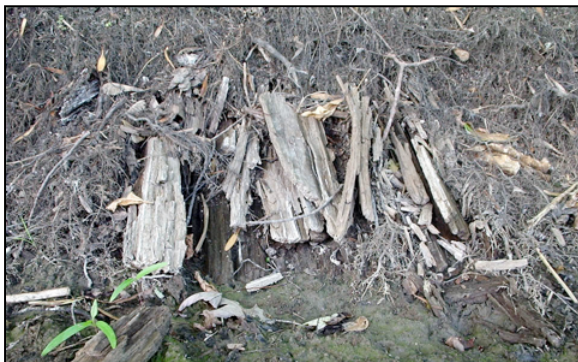
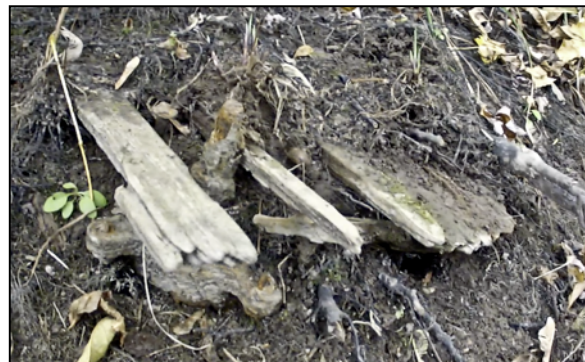
The wooden structure seen in 2008 (left) and in 2015 (right), with the iron plate and five bolts visible.

Possible Wreck Site. Every lumber mill located on the river in Aitkin during the 1880s into the early 1900s had rudimentary docks or walkways in the river channel. These structures assisted workers in dealing with logs running down the river and securing watercraft. The docks or piers in this section of the Headwaters Mississippi River were not large constructions or meant to be incredibly sturdy or permanent, unlike the Sandy River Steamboat Crib Site (21-AK-117),¹³ since steamers most often used gangplanks for the off-loading of cargo and passengers. These mills also had log slides or chutes leading to the river that served as infrastructure for logging enterprises. It is apparent that some of the archaeological remains lying to the south of the Red Mill Wreck are related to the logging and lumbering undertaken at the G. W. Knox Saw and Planing Mills. A wooden structure, imbedded in the riverbank, is held together by an iron plate with 5 large bolts. It resembles the planks or decking of a boat that are attached to an

underlying wooden piece that suggests a deck beam. However, this construction might also be a dock or possibly a logging slide or chute. This feature was located in 2008 and re-located in 2015. A concrete plinth above this area is evidence of maritime infrastructure once located on the riverbank that supported the mill operation. Additionally, a decayed timber found jutting out of the riverbank in 2008 was re-located in 2015. Unfortunately, water levels were too high in early October 2015 to associate a spread of bricks that were exposed in 2008 to the wood and metal feature in the riverbank. The bricks could suggest a steamer wreck, as part of its firebox, or construction debris from a building on the riverbank. The concentration of the bricks in one spot in the river channel suggests the firebox hypothesis is more likely. Shovel testing of this area is necessary to answer questions about the obvious archaeological remains located here; probing was not sufficient to answer any questions. Low water conditions are necessary for an effective investigation.

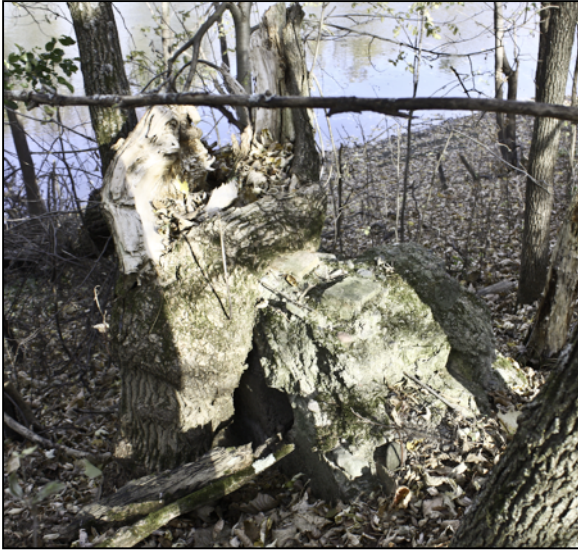
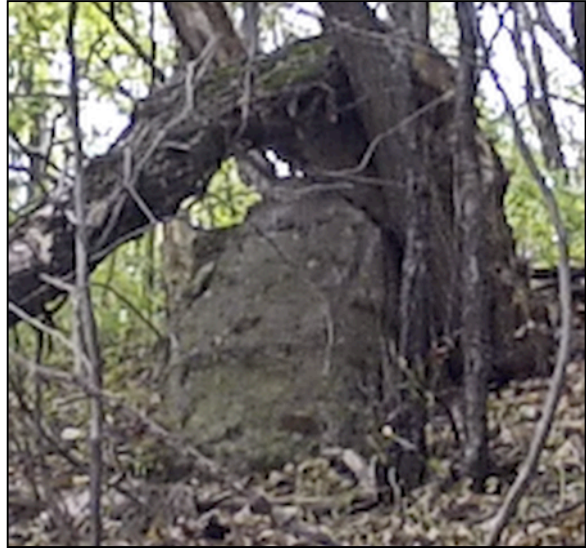
The concrete plinth from two directions, with a tree growing around it. The plinth is up the riverbank just to the southwest of the wooden structure with the metal plate.

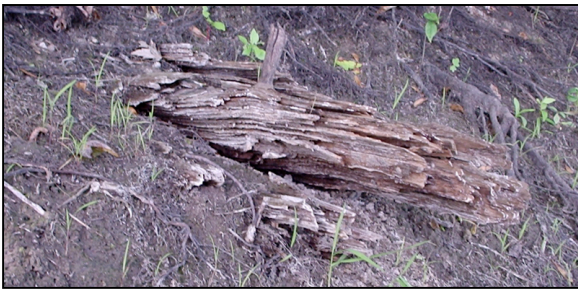
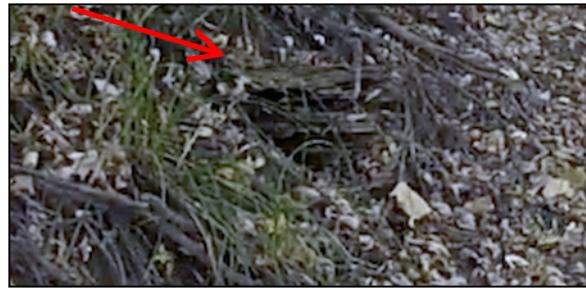
The decayed timber jutting out from the riverbank. It has degraded since 2008.

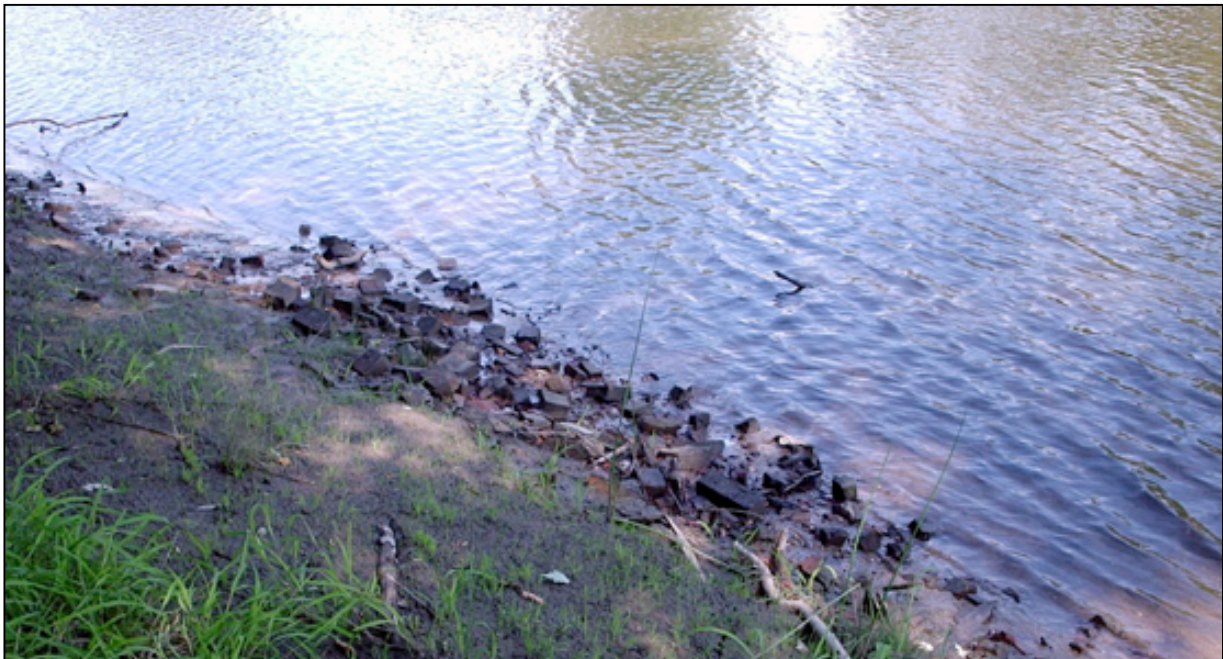
This spread of bricks, seen here in 2008, is only exposed during very low water south of the Red Mill Wreck.
